A Preliminary Study of Flood Remediation in Hebden Bridge and Appleby

Prepared for Historic England by
Dr Brian Ridout, Chris Wood and Iain McCaig

This report presents some preliminary findings of site visits to properties in Hebden Bridge, West Yorkshire, and Appleby-in-Westmorland, Cumbria, ten months after the severe flooding that occurred in December 2015. The purpose of the visits was to investigate different responses and remediation methods, and assess how successful they have been.

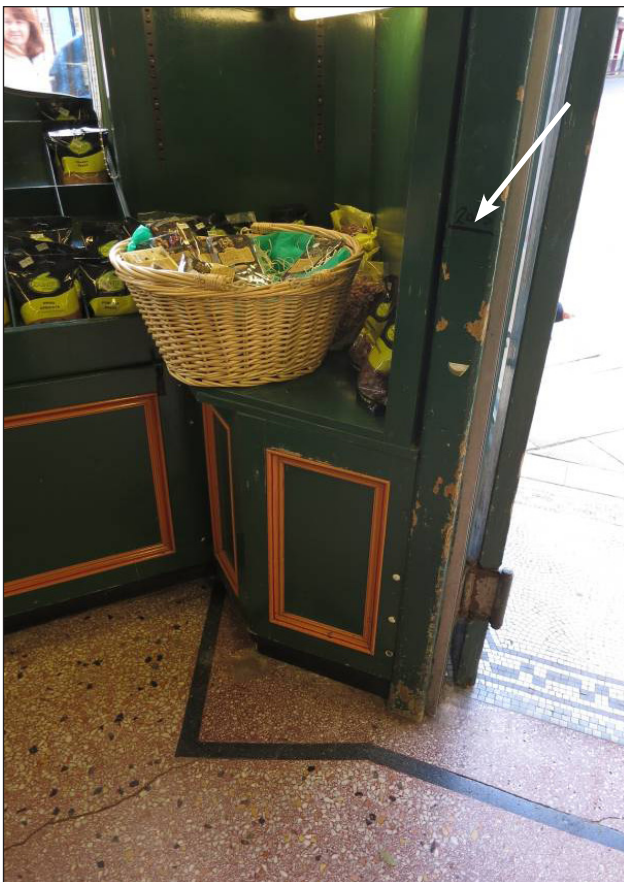
1m (indicated by arrow in Figure 3).

Figure 3: Arrow indicates the approximate depth of water above ground floor level.

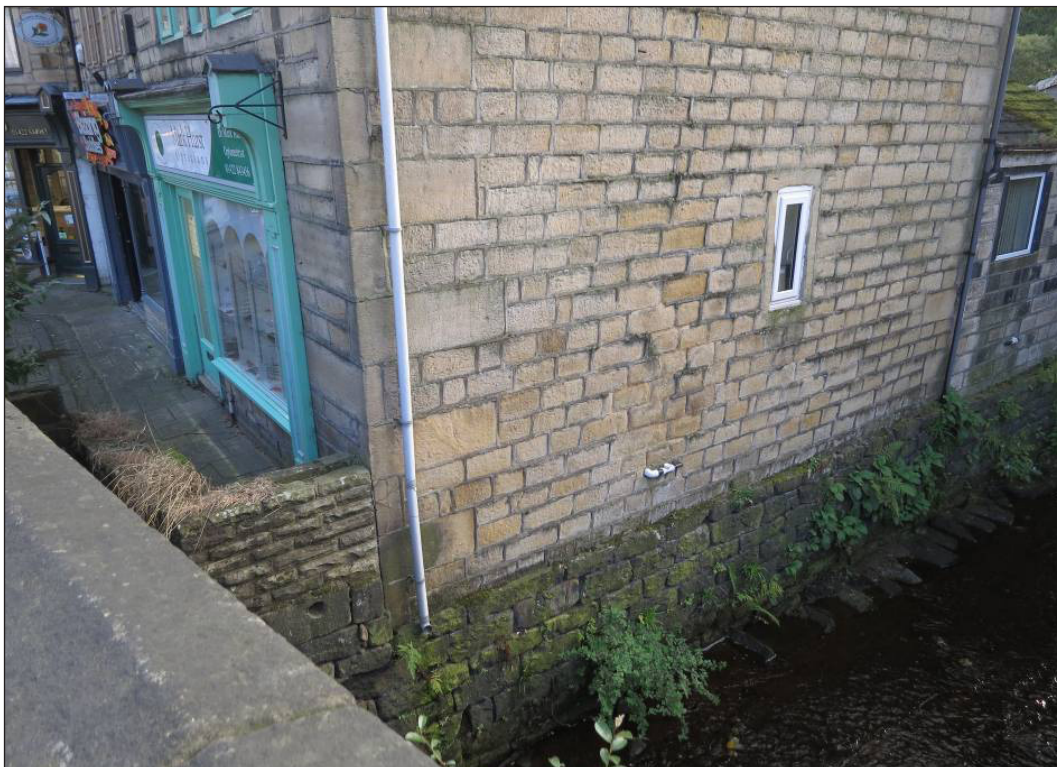
Not clear, but shop is on the banks of the river (Figure 8) so that flood water would have drained as soon as the river dropped.

Figure 8: The shop is located on the banks of the river.
