A Preliminary Study of Flood Remediation in Hebden Bridge and Appleby

Prepared for Historic England by
Dr Brian Ridout, Chris Wood and Iain McCaig

This report presents some preliminary findings of site visits to properties in Hebden Bridge, West Yorkshire, and Appleby-in-Westmorland, Cumbria, ten months after the severe flooding that occurred in December 2015. The purpose of the visits was to investigate different responses and remediation methods, and assess how successful they have been.

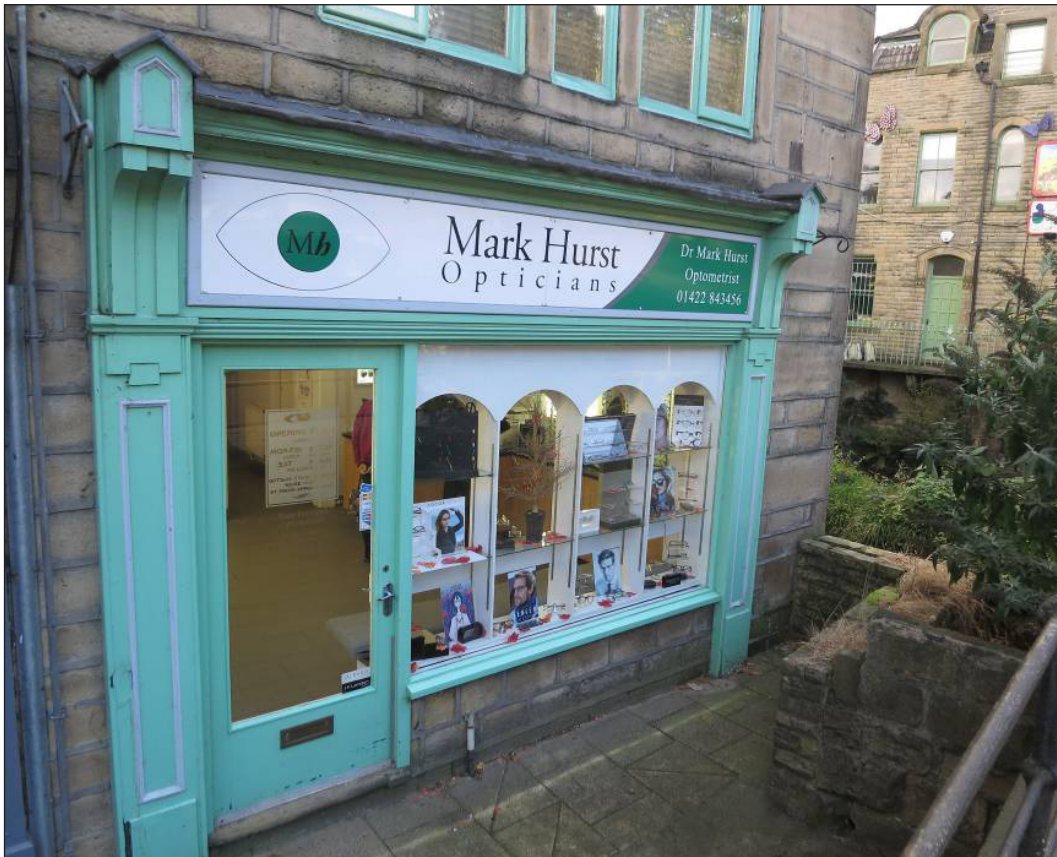
Cleaning and disinfectant. Dehumidifiers used.

Figure 7: The shopfront of Mark Hurst, opticians.
